# ARE WE REALLY LEARNING" A Case study- Still Going Wrong" PRAKASH TATA, Author

This Presentation which is part of my forthcoming book titled "Are We Really Learning?" whose idea got inspiration from Last ASSP PDC where I got inspiration to go through all global catastrophic incidents. In this book I am working on a new age "Process Safety Management" process - "MLW-CAR-TOWARDS SOCIETAL RISK"

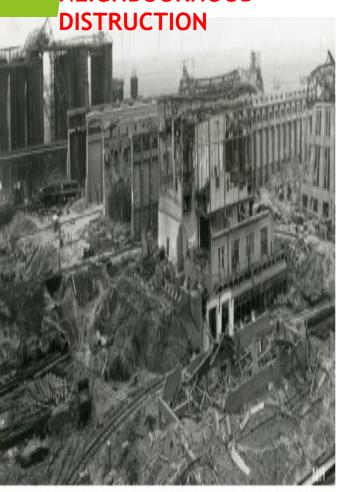
- ➤ The introduction of a new drying process for ammonium sulfate nitrate (spray process, "Spritzverfahren") caused changes in all these parameters resulting in a salt with increased explosiveness.

- In addition a dust-like fine fraction with increased ammonium nitrate content was formed which accumulated at the edge of the silo.

- > It can be assumed that on the day of the accident at least one of the explosions for loosening the caked salt was carried out in the area of the fine fraction, thus initiating a detonation of this fine fraction and causing the detonation of further fractions with approximately "normal" nitrate content.
- This accident is a strong example for the need of Management of Change (MOC) procedures, which are an integral part of today's process safety.
- > Lack of care by operators induced by introduction of a new bonus system which was linked to the production quantity
- Introduction of the new spray process Deviations from the operating procedures resulting in the addition of wrong amounts of AS (too little) or AN (too high)
- > Fine dust in 100 of tons ignored settling down with a thickness of 0.5m has created as dust cloud which lead to the explosion.

- Management of Change: Before implementation of a process change the consequences to process safety must be checked and the safety concept must be updated
- In particular the influence of the process change upon the safety characteristics of the handled materials must be determined
- If a process has an extremely high hazard potential, it must be impossible that one single fault (e.g. a deviation from the correct chemical composition of ASN) can activate this hazard potential

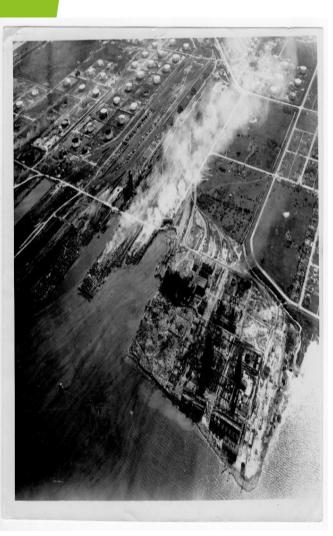
SS GRANDCAMP Explosion at Texas Port

- carrying combustible material sisal, cotton and peanuts, small arms ammunition and Ammonium Nitrate bags produced during war time and later to be used as fertilizer.
- Early in the morning fire was caught.
- > The ship exploded while fire control measures were being carried out.
- The entire dock area got destroyed along with nearby Monsanto chemical company, smaller companies, wear houses, storage tanks.
- Flying debris prompted more explosions and tidal wave of 13ft(4 Meters) high has swept the dock area, destroyed minimum 1000 residences and buildings.

- Always treat any scene with ammonium nitrate, or any other explosive compound, as just that, an explosive device
- First responders do not have the appropriate PPE to protect ourselves from any energetic material.

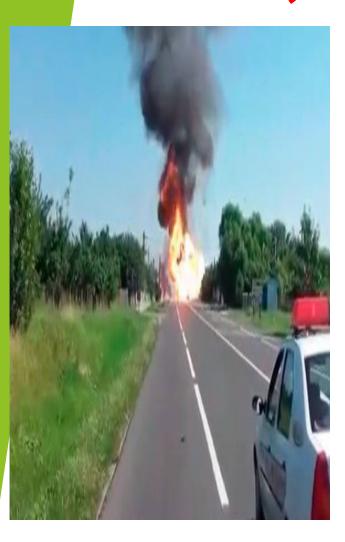
#### MAY 24, 2004- MIHALESTI ROMANIA

The consequences of the accidents were catastrophic: - 18 deaths (fire-fighters, local people, reporters, policemen), 11 injured;

- 150 m of E85 road destroyed; 16 houses damaged: windows broken or roof damaged; 6 private cars damaged or destroyed; 2 fire-fighter trucks heavily damaged; electrical supply network of Mihailesti village damaged. Heavy pieces from the truck were projected at hundreds of meters, the central axle of the truck weighting 1.5 t being found in the roof of a house at 250 m from the accident.

- Learning from the incident:
- A general conclusion is that both accidental and deliberate accidents will continue to occur unless best practices are implemented in industry and transportation and unless lessons learned from past accidents are applied. Considering the earthquakes measured at Istria station it can be concluded that two explosions took place in the case of Mihăilesti accident. The first explosion was weaker and a lower TNT equivalency could be associated with it. The second explosion was probably a detonation and a high TNT equivalency should be associated. A more detailed analysis of the Mihăilesti explosion is necessary for the determination of TNT equivalencies.

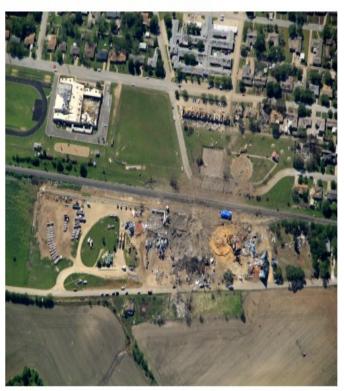
WEST FERTILIZER COMPANY FIRE AND EXPLOSION (15 Fatalities, More Than 260 Injured)

- ➤ On April 17, 2013, a fire and explosion occurred at the West Fertilizer Company (WFC), a fertilizer blending, retail, and distribution facility in West, Texas. The violent detonation fatally injured 12 emergency responders and three members of the public. Local hospitals treated more than 260 injured victims, many of whom required hospital admission. The blast completely destroyed the WFC facility and caused widespread damage to more than 150 offsite buildings

- The explosion happened at about 7:51 pm central daylight time (CDT), approximately 20 minutes after the first signs of a fire were reported to the local 911 emergency response dispatch center. Several local volunteer fire departments responded to the facility, which had a stockpile of between 40 and 60 tons (80,000 to 120,000 pounds) fertilizer grade ammonium nitrate (FGAN), not counting additional FGAN not yet offloaded from a railcar leading Indicators Ignored/Violated:

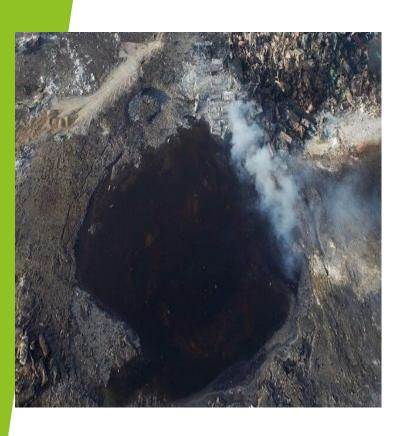
Series of explosions that killed over one hundred people and injured hundreds of others occurred at a container storage station at the Port of Tianjin on Wednesday, 12 August 2015. The first two explosions occurred within 30 seconds of each other at the facility, which is located in the Binhai New Area of Tianjin, China. The second explosion was far larger and involved the detonation of about 800 tons of ammonium nitrate. Fires caused by the initial explosions continued to burn uncontrolled throughout the weekend, repeatedly causing secondary explosions, with eight additional explosions occurring on Saturday, 15 August.

The cause of the explosions as per later concluded investigation in February 2016 that an overheated container of dry nitrocellulose was the cause of the initial explosion.

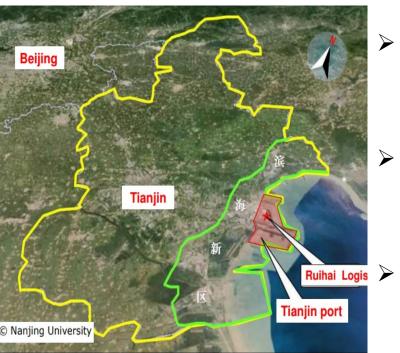
- As of 12 September 2015, the official casualty report was 173 deaths, 8 missing, and 797 non-fatal injuries.
- ➤ 304 buildings, 12,428 cars and 7,533 containers were badly destroyed.

- Environment damage: 320.6 tons of sodium cyanide and a large amount of other chemicals were dispersed.
- August 12, 22:51:46: fire, 23:34:06 (~45 min later): the first explosion, 23:34:37 (~30 sec later): the second explosion. August 14, 16:40: the fire was extinguished.

- According to the on-site staffs, the video, the trace evidences, and the destruction and displacement characteristics of the containers, the central area of the dangerous goods container storage station was identified as the initial fire point.

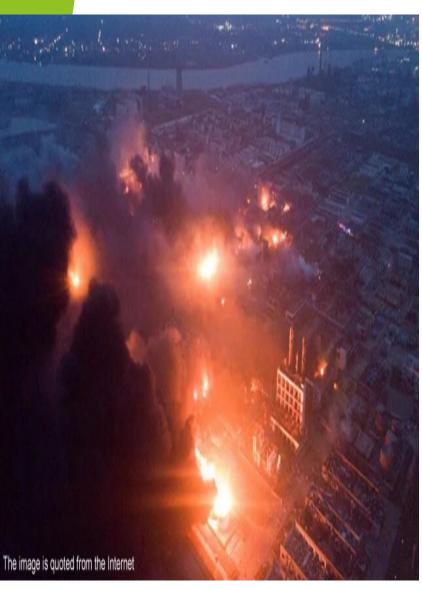
The March 2019 explosion occurred at a local time of 14:48 (06:48 GMT). 78 people were killed, and at least 94 were severely injured, 32 of whom were critically injured.

The injured included children at a local kindergarten. CNEC detected an  $M_1 2.2$  artificial earthquake whose epicenter is at 34.331°N 119.724°E. The force of the blast started numerous fires in Yancheng, knocked down several buildings, and reportedly destroyed windows several kilometers away. The fire was reported to have been controlled by 03:00 local time. Considerable damage was caused to nearby factories and offices; the roof of Henglida Chemical Factory, 3 km from the explosion, fell in. At least one of the people killed was in another building destroyed by the blast. Windows are reported to have been blown out up to 6 km away from the explosion, and houses and other buildings were damaged in the nearby village-level administrative divisions including Hai'an Town (Haianju) and Shadang. This explosion was strong enough that it registered on earthquake sensors and could be seen by satellites. The blast created a crater resulting in a magnitude 2.2 seismic shock that took over 900 firefighters to get the fire under control.

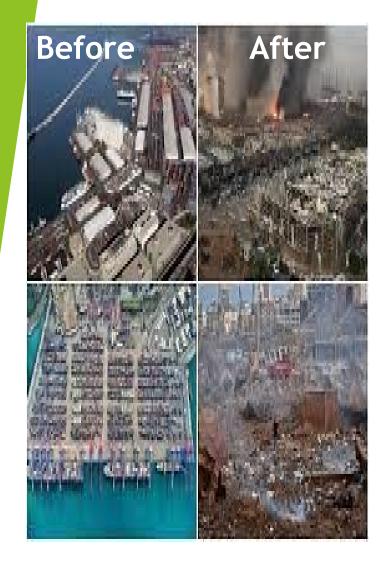
- The Beirut port Ammonium Nitrate explosion killed 218 people, including nationals of Lebanon, Syria, Egypt, Ethiopia, Bangladesh, Philippines, Pakistan, Palestine, the Netherlands, Canada, Germany, France, Australia, and the United States.

- It wounded 7,000 people, of whom at least 150 acquired a physical disability; caused untold psychological harm; and damaged 77,000 apartments, displacing over 300,000 people.

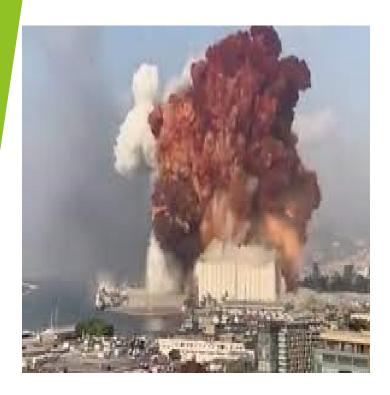
- It resulted in ammonia gas and nitrogen oxides being released into the air, potentially with toxins from other materials that may have also ignited as a result of the explosion. Ammonia gas and nitrogen oxides are harmful to the environment as well as to the respiratory system.

- ➤ Destruction is estimated to have created up to 800,000 tonnes of construction and demolition waste that likely contains hazardous chemicals that can damage health through direct exposure, or soil and water contamination.
