## “Styrene Gas Leak Incident post COVID -19 Lockdown in Vizag”

**Mr. Rizwan Parkar**  
**PSM Engineer - KOC**  
**20-July-2022**

# INCIDENT SUMMARY

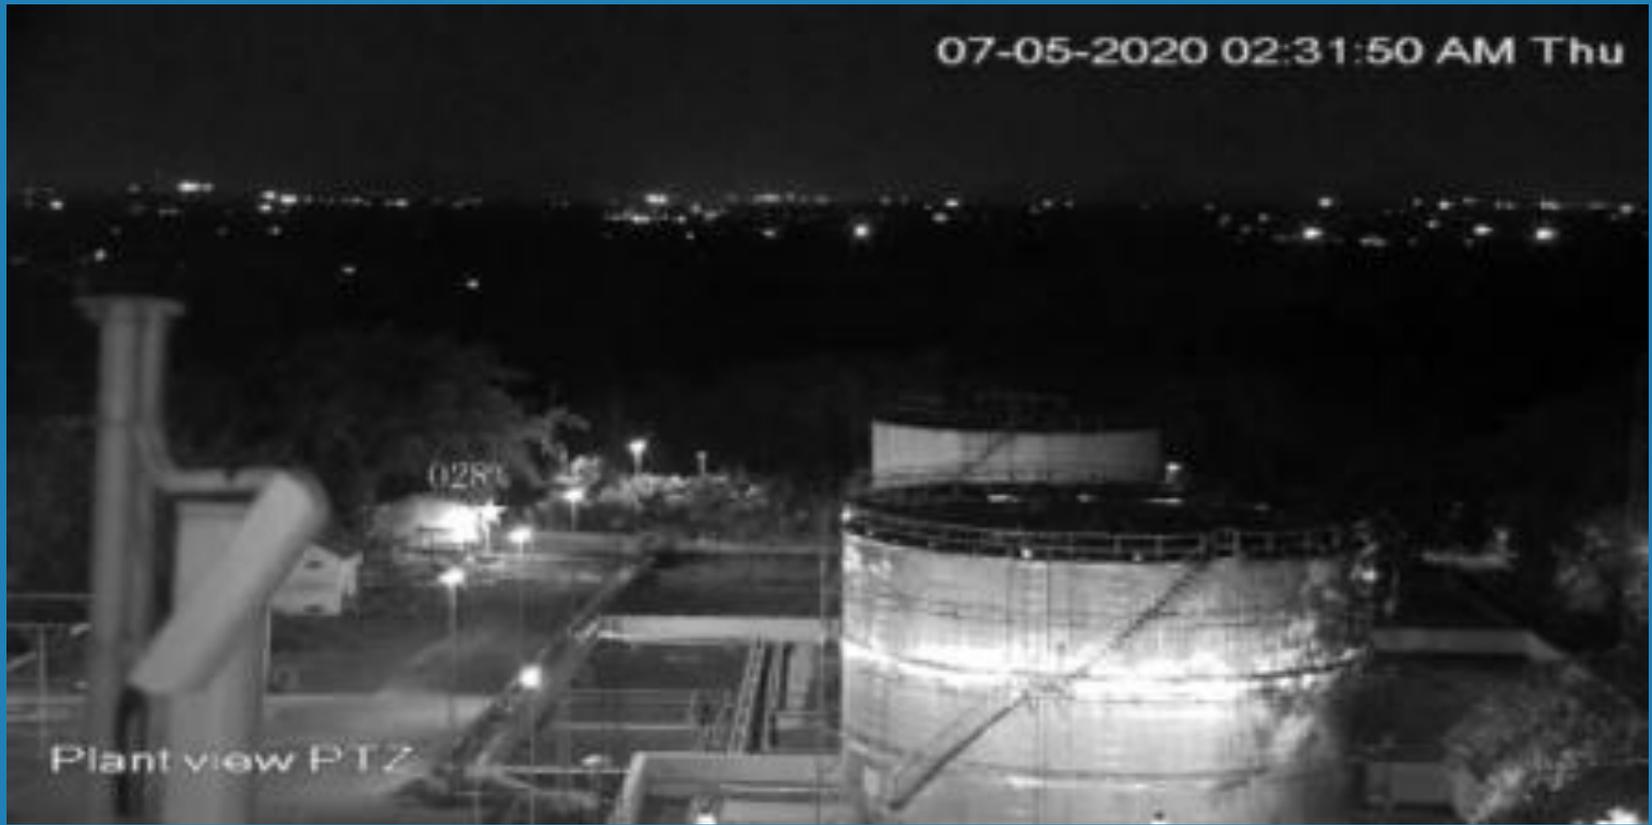
# INCIDENT PHOTO - 1

**M6 Tank (Normal Condition)**

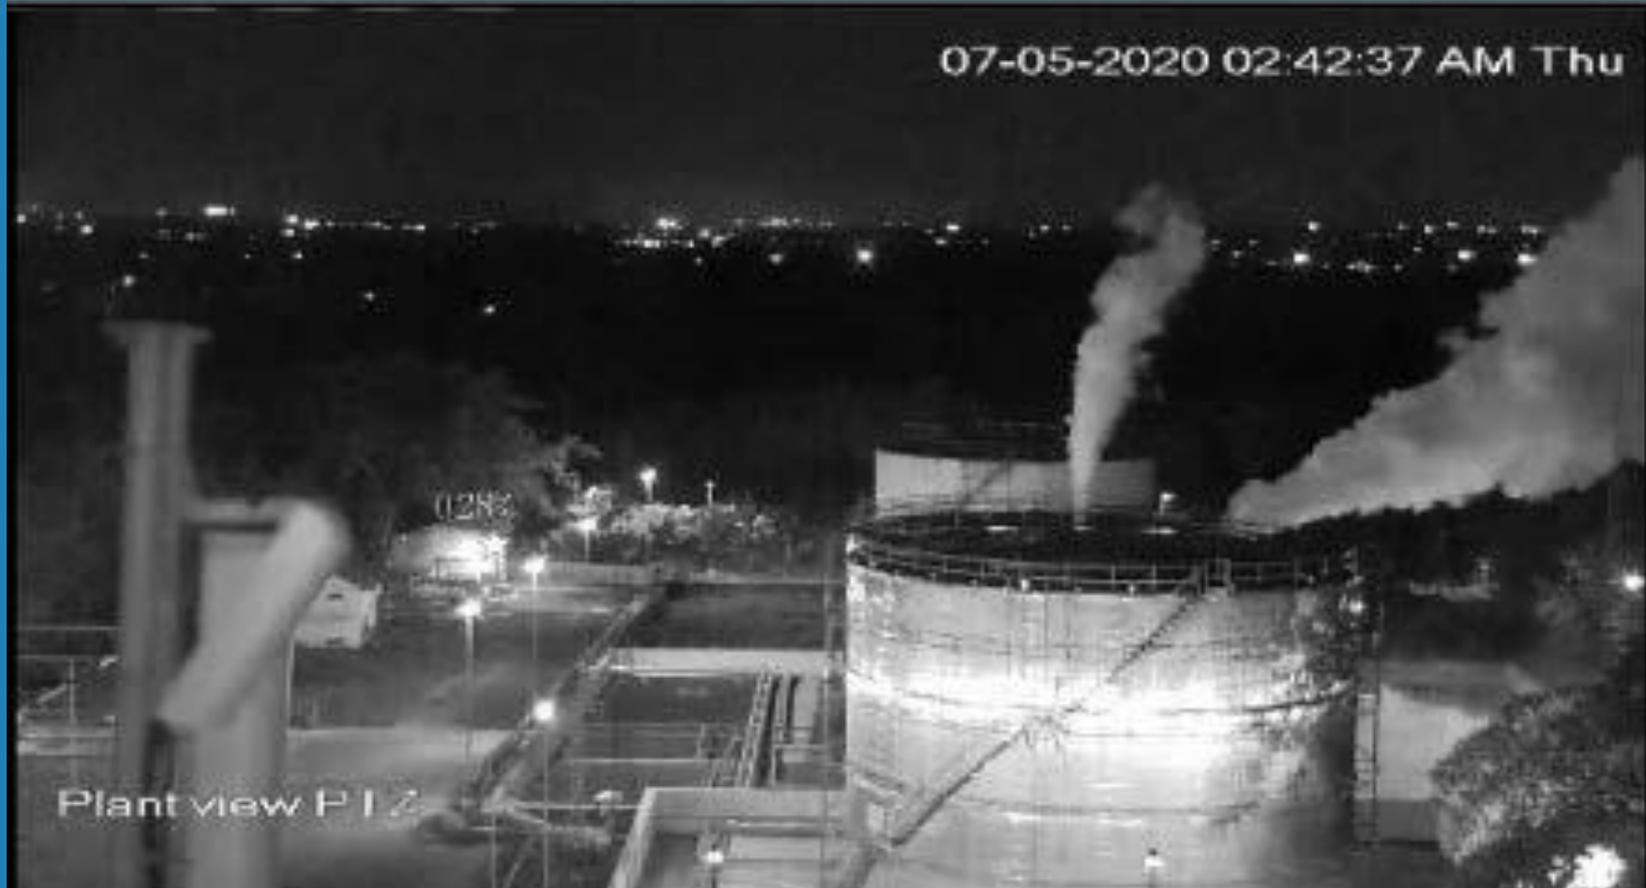
# INCIDENT PHOTO - 2

**Styrene Vapor Release from M6 Tank**

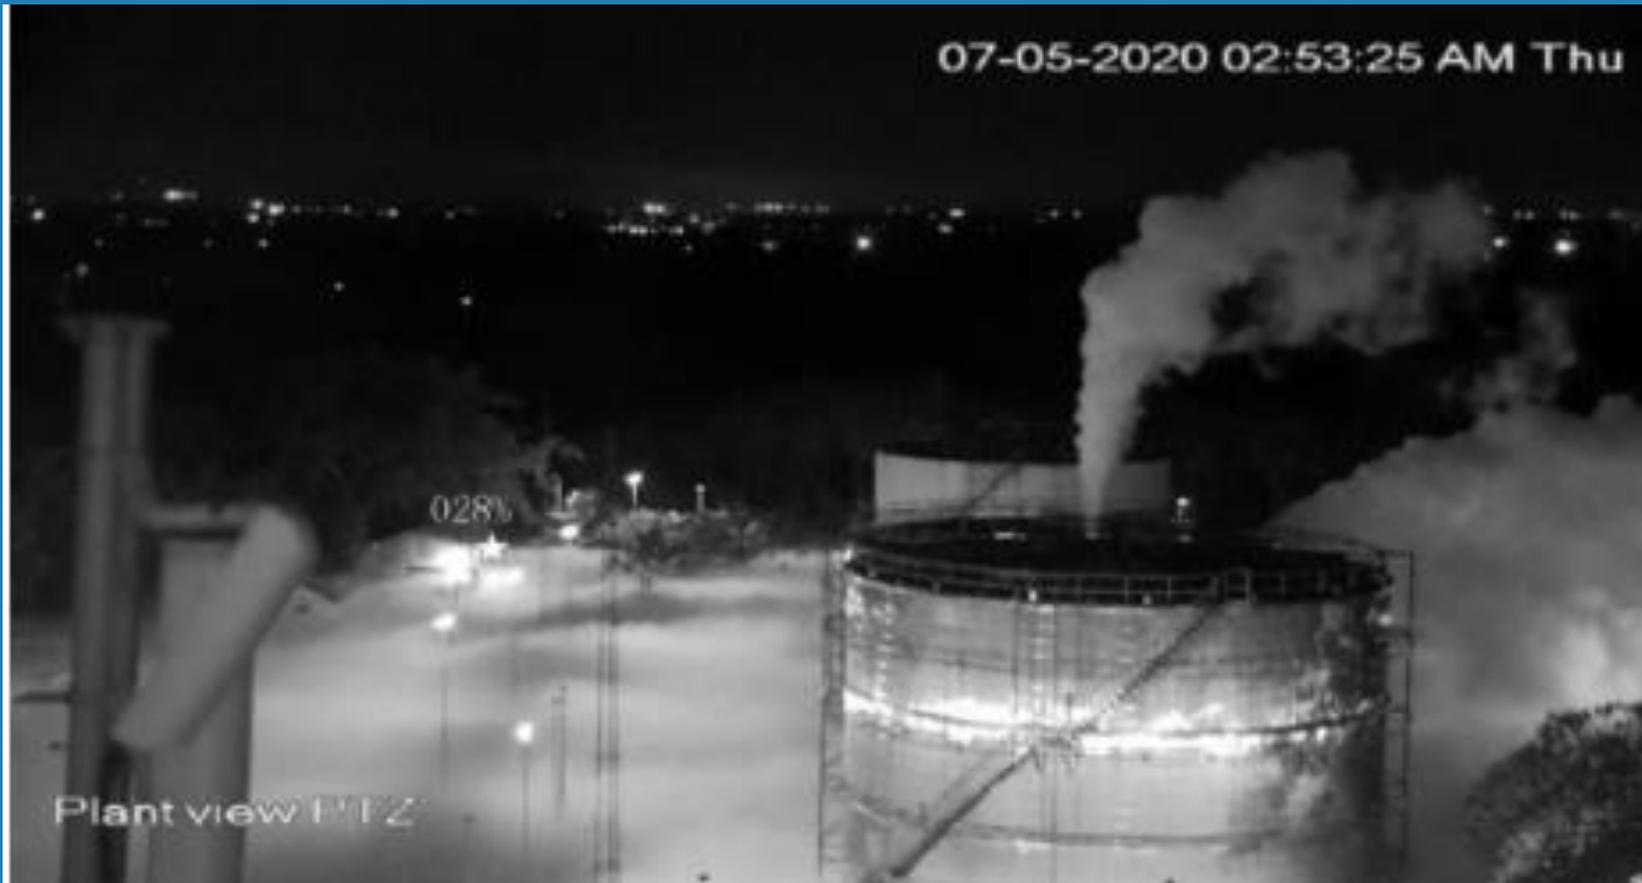
# INCIDENT PHOTO - 3

**Styrene Vapor Cloud Formation**

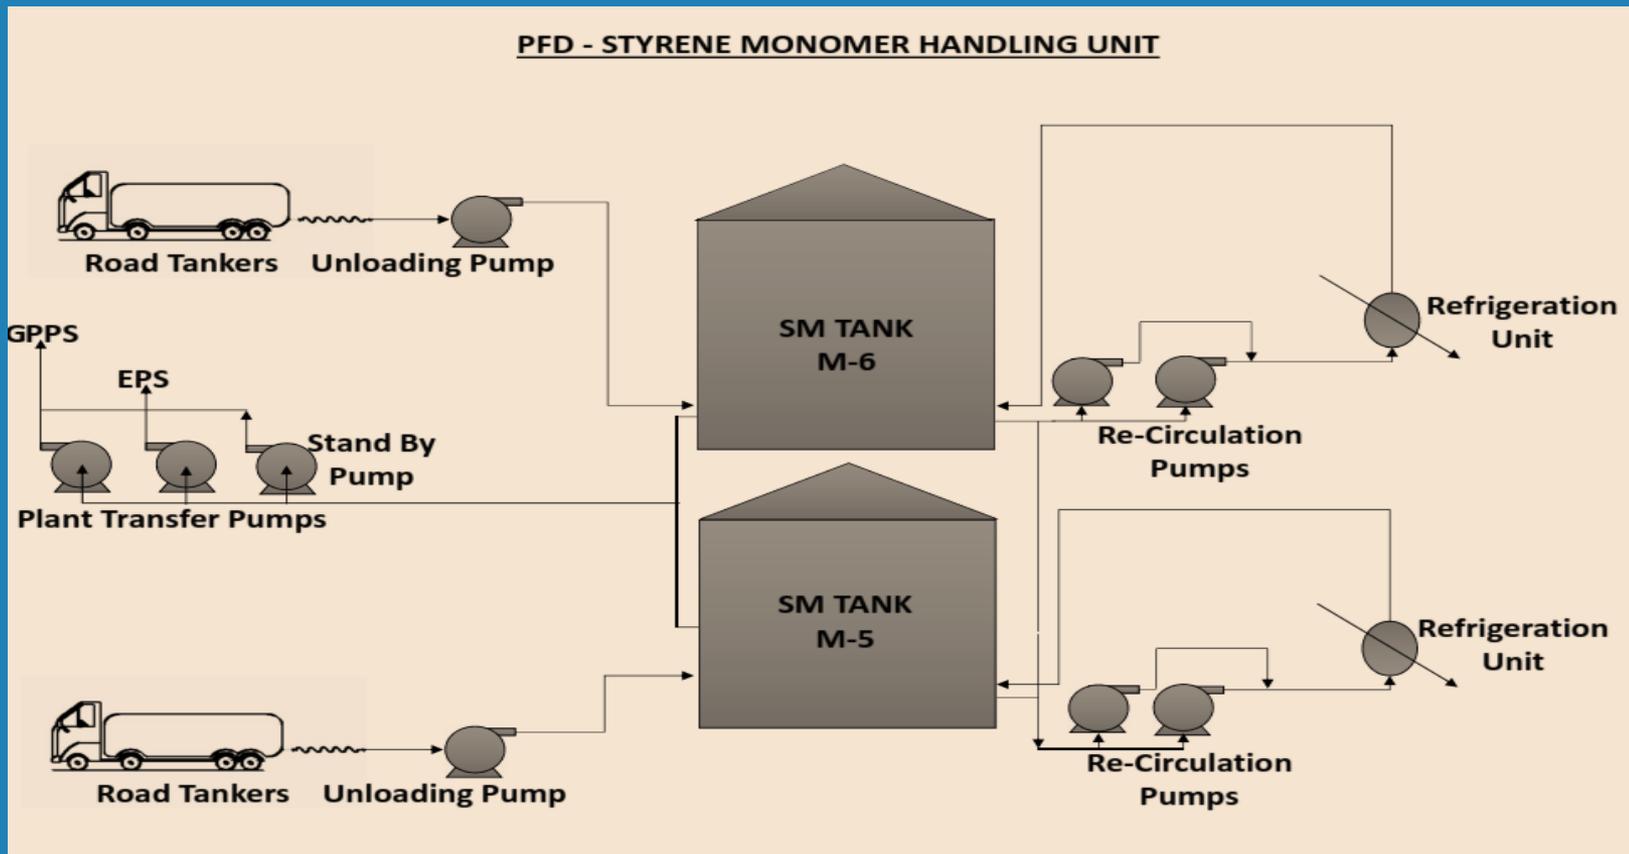
Schematic Diagram of Styrene Handling Plant
