# ARE WE REALLY LEARNING" A Case study- Still Going Wrong" PRAKASH TATA, Author

This Presentation which is part of my forthcoming book titled "Are We Really Learning?" whose idea got inspiration from Last ASSP PDC where I got inspiration to go through all global catastrophic incidents. In this book I am working on a new age "Process Safety Management" process - "MLW-CAR-TOWARDS SOCIETAL RISK"

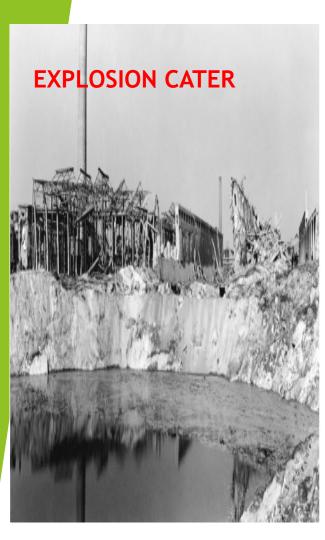
- > On 21. September 1921 the explosion of an ammonium sulfate nitrate silo in Oppau killed 507 and injured 1917 people.
- > 4500 Tons of Ammonium Sulfate Nitrate was stored.

- Ammonium sulfate nitrate is a mixture of 2 salts: ammonium nitrate (explosive) and ammonium sulfate (inert). The explosiveness of the mixed salt is mainly determined by the ratio of these 2 salts. The influence of the mixed salt composition on the sensitivity to detonation impact had been thoroughly investigated before the accident as it was common practice to use small explosive charges to loosen the salt which had solidified during storage in the silo.

- About 20.000 blasting operations were carried out without any notable incident. Experiments conducted after the accident revealed that several physical parameters (particle size, density, water content, homogeneity of crystal structure) also had an influence.

- ➤ The introduction of a new drying process for ammonium sulfate nitrate (spray process, "Spritzverfahren") caused changes in all these parameters resulting in a salt with increased explosiveness.

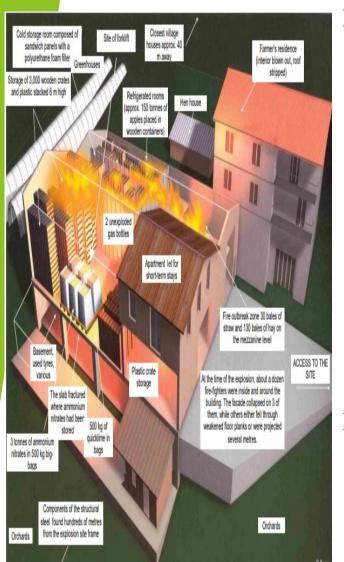
- > On Thursday, October 2, 2003, at around 3 pm, a fire broke out inside the barn of the tree farmer at the mezzanine level used to store, among other items, bales of hay and straw. Alerted by his son who had smelled the emanating smoke, the farmer unsuccessfully tried to put out the fire using an extinguisher. Fire-fighters were notified about a farm fire at 4:02 pm. Upon arriving on the scene, at 4:23, they had to battle an extremely violent barn blaze responsible for releasing an impressive plume of smoke. The crew set out to extinguish the main source of combustion, with the aim of saving the house adjoining the barn using 4 variablerate nozzles, yet the team quickly faced water supply interruptions. The captain called for a "water supply backup" unit at 4:38 pm. The fire-fighting strategy adopted had to be adapted to both the amount of water resources and the fire's progression. Once the house was out of danger, fire-fighters turned to two variable-rate nozzles in order to protect the flat that was still intact on the barn's first floor.
